Case Study

POOL DECK SOIL STABILIZATION & CAVITY FILL WITH HMI DEEP FOAMJECTION

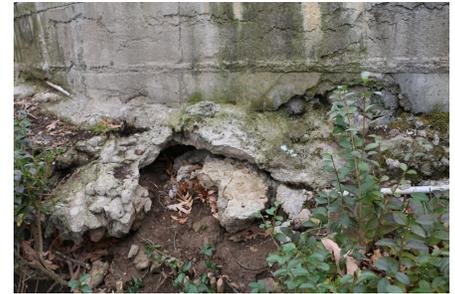
Cavity Beneath Wall

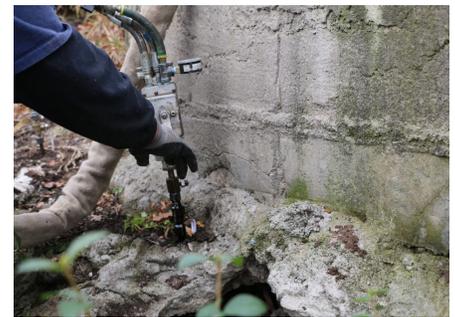
Injecting HydroFoam

In one day, three team members from Bravo injected 538 lbs of Hydrofoam (immune to water) through piping 3/8 inch in size. The soil beneath the pool and outer edge was 100% stabilized and all voided cavities were filled. The homeowners were very pleased with how clean and quick the process was. They would recommend to any other home owner or business owner who sees the same issues on their property.

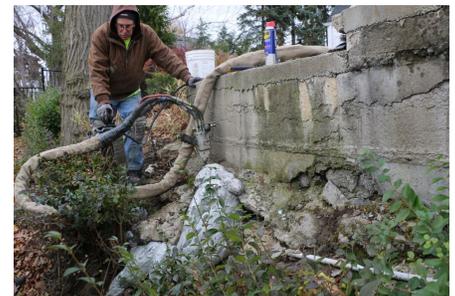
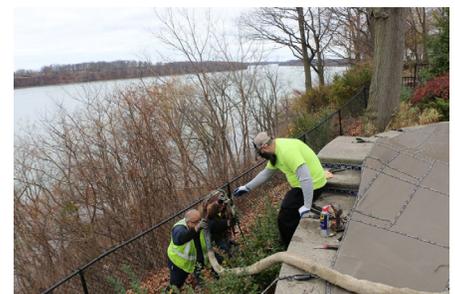
45 Degree Slope Down to River
